*Tero Kiviniemi, M.Sc. (C.E.)
Assistant Director
YIT Construction Ltd
Finland, Helsinki*

Realization of the Joensuu Hall – from the theory to the practice

Introduction

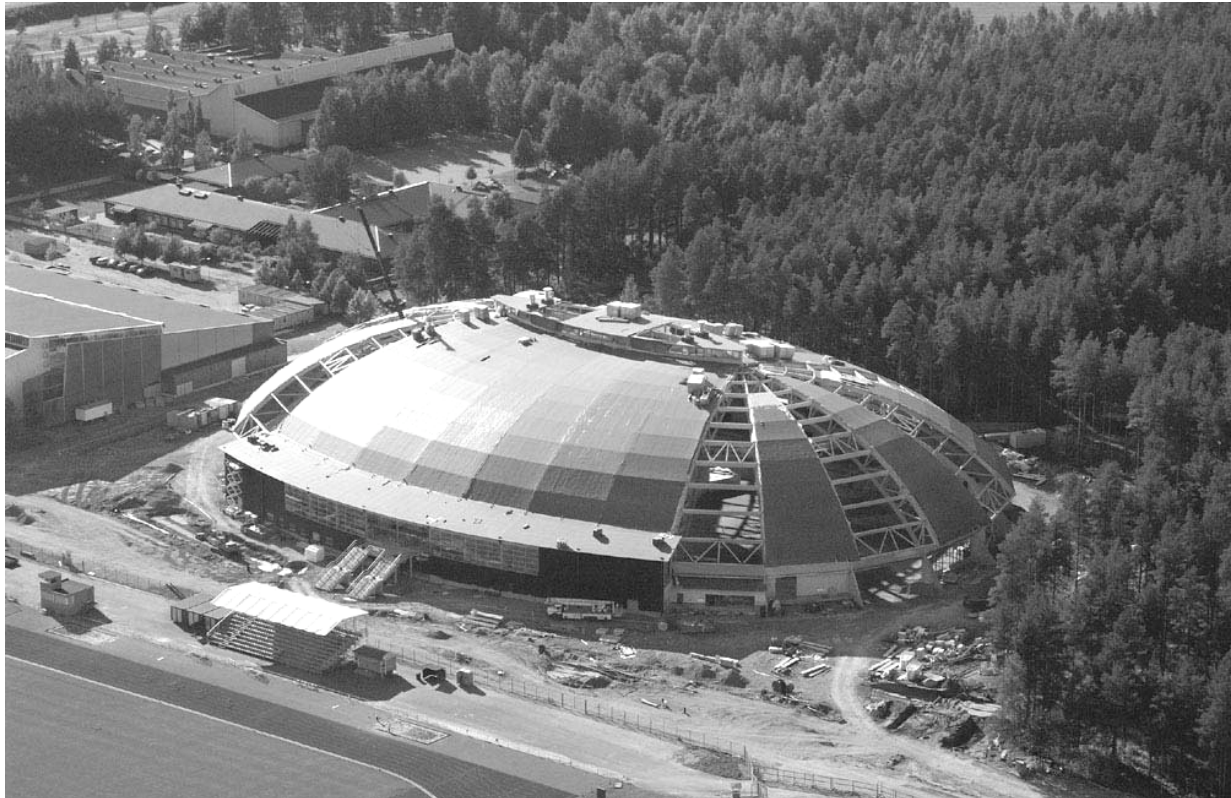
Picture 1: The Joensuu Hall under construction in the autumn of 2003

When completed in January 2004, the Joensuu Hall will be the largest wood building in Finland, measuring 150 m in length and 110 m in width. It will have a total surface area of 14,654 m² and a cubical capacity of 262,510 m³.

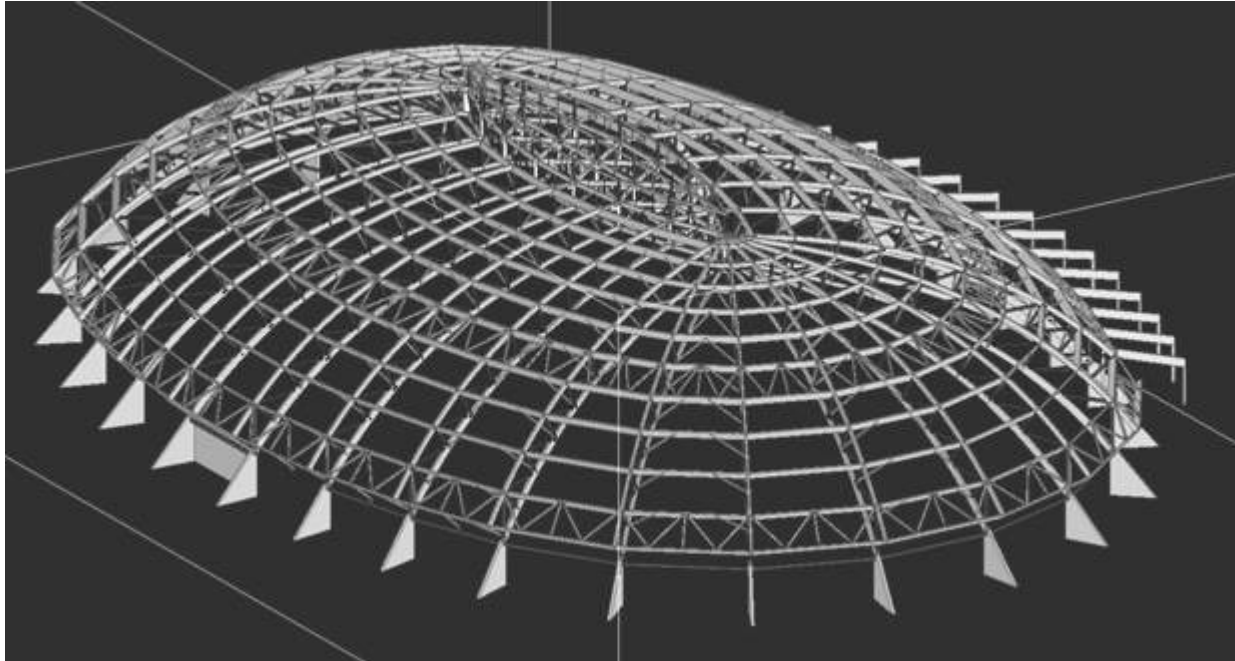
The main structure of the hall is formed of a cross-supporting cupola lying on an oval-shaped base. The main spans of the dome are 145 x 100 meters. As the structure is load-bearing in both of the main axis directions, the forces affecting the individual arcs have been minimized. The height of the top of the cupola is 31 m and the supporting primary structures are glued laminated timber (gluelam) and Kerto-LVL-structure trussed arcs. In their final configuration, these 28 separate arcs function as 2-linked arcs.

Picture 2: General view of the frame structure

In the middle of the hall the arc-halves sectorially join in a timber-structure space truss construction whose shape is reminiscent of a boat. It creates a dominating visual and structural reference point to the hall, both when viewed from the outside and the inside. The geometry of the central part is similar to that of the edge of the external wall – shaped like an oval – and thus all the main arcs are geometrically similar. In the skylight structure, the load transferring members are positioned diagonally compared with the direction of the flanges of the main arcs.

The secondary structures of the ceiling are gluelam- and Kerto-LVL-structure purlin beams, which are buckling supports with tie struts at the main bend. The fire resistance of the primary structures of the frame is 30 minutes and that of the secondary structures is 15 minutes. In addition, there will be a sprinkler system and mechanical smoke abatement equipment because of the client's demands.

The hinged support points of the main trussed arcs are located about 4.5 meters above ground, and will be connected to in-situ cast concrete walls based on piled footings. The vertical and horizontal components of the resultant arc support loads of approximately 2.5 MN, the obliqueness of the resultant being ca. 45°. Oblique forces on the main arcs will be carried by steel tube piles that are vibrated to a 45° angle. Pile lengths vary between 3-12 m. The joints of the trussed arcs will be made with steel plates and dowels. The joints between the arc blocks will be made using traditional steel joint techniques.

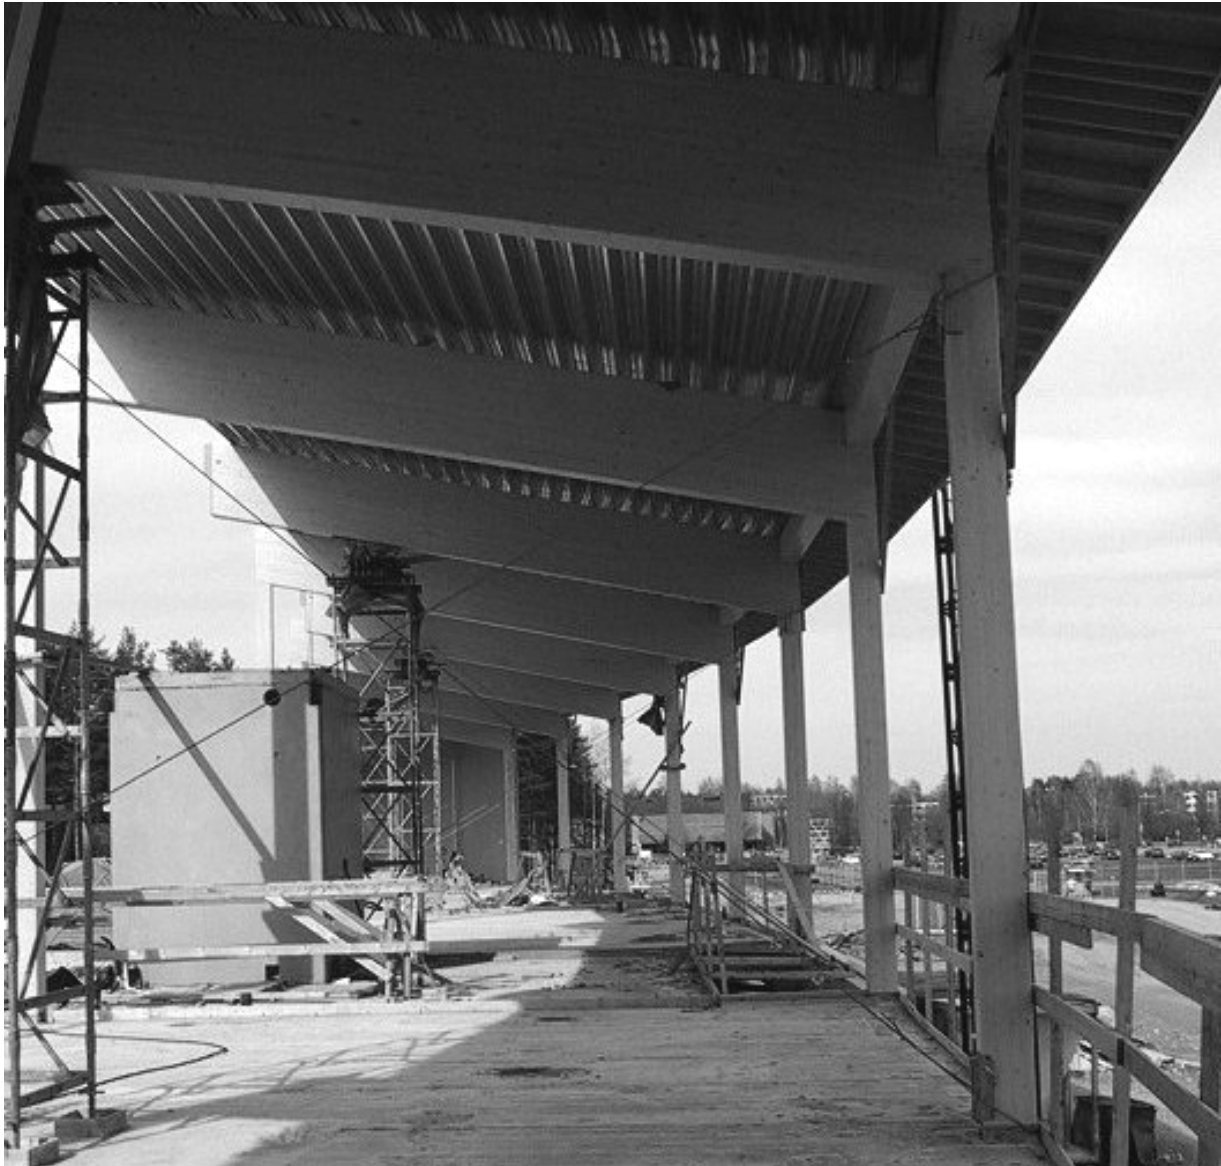
On-site installation works were started up in March with the wood columns and beams of the service premises. The aim was to roof the service premises as soon as possible, so that the extensive indoor construction works required in these premises could be started up. The wood frame of the service premises was conventional and easy to install.

Picture 3: Installation of the wood frame of the service premises

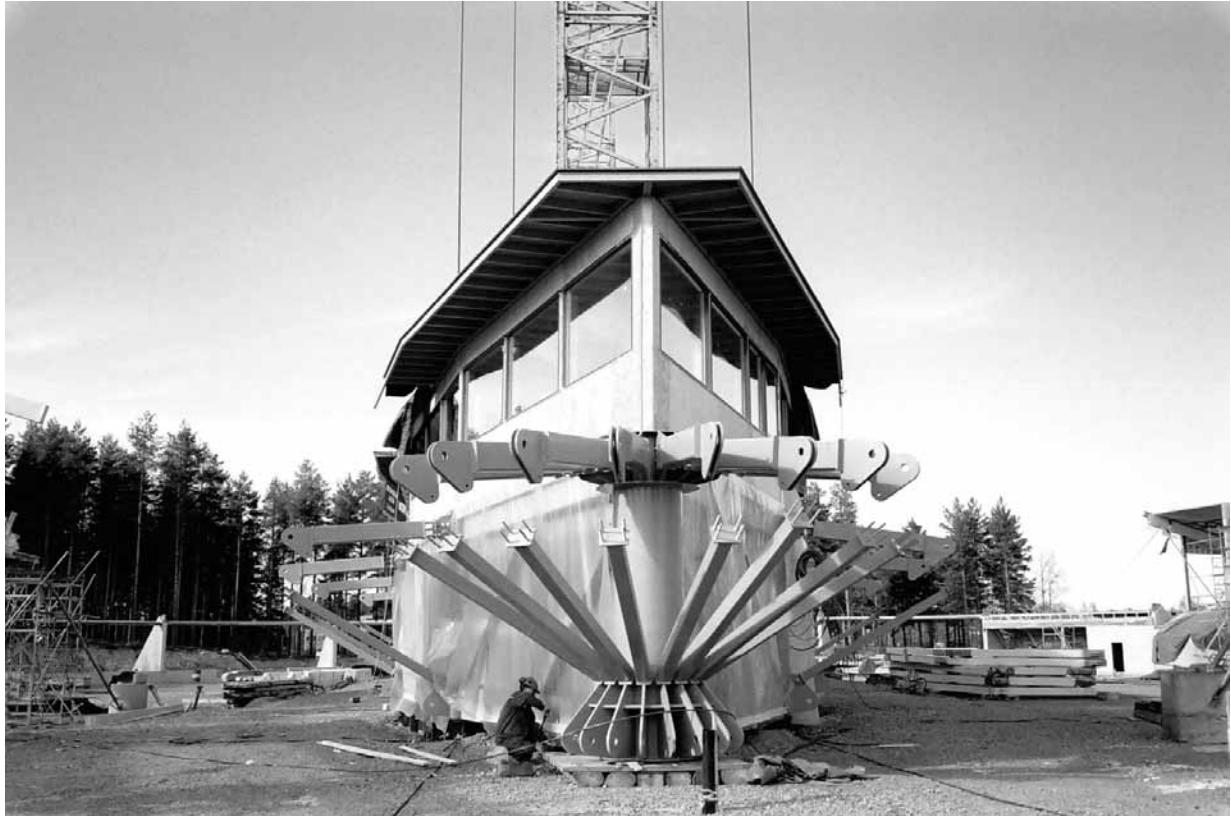
The installation of the frame of the hall section began with the assembly of the space truss on top of steel-structure lifting beams in the middle of the hall. Because the plane frameworks were connected with steel bolt joints, this stage resembled the installation of a steel frame. The dimensional accuracy of the elements meant that this geometrically demanding structure could be installed rapidly without encountering dimensional problems. The installation of the roof, outer walls, windows and building systems of the space truss and their painting were also performed on the ground to save on costs and time.

Picture 4: Installation of the space truss

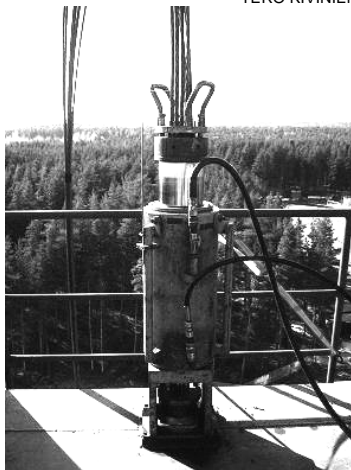
After the completion of the installation works, the space truss was hoisted onto two support towers using four hydraulic jacks having a hoisting capacity of 120 tonnes each. The load was 55 m long, 11 m wide and about 6 m high and had a mass of about 150 tonnes. Hoisting was halted at a height of about 14 metres to minimize the wind stresses the load was subjected to. However, the achieved height was enough to ensure that the space truss was not in the way of the other installation works. The hoisted space truss was guyed into place with eight steel cables dimensioned to withstand storm winds, that is, winds of over 21 m/s. The use of hydraulic jacks for hoisting proved to be the right choice, because the height of the four hoisting points could be controlled to an accuracy of a few millimetres, and thus the frame was not subjected to additional burdens. The motion of the mobile cranes could have been substantially rougher.

Picture 5: Hydraulic jack

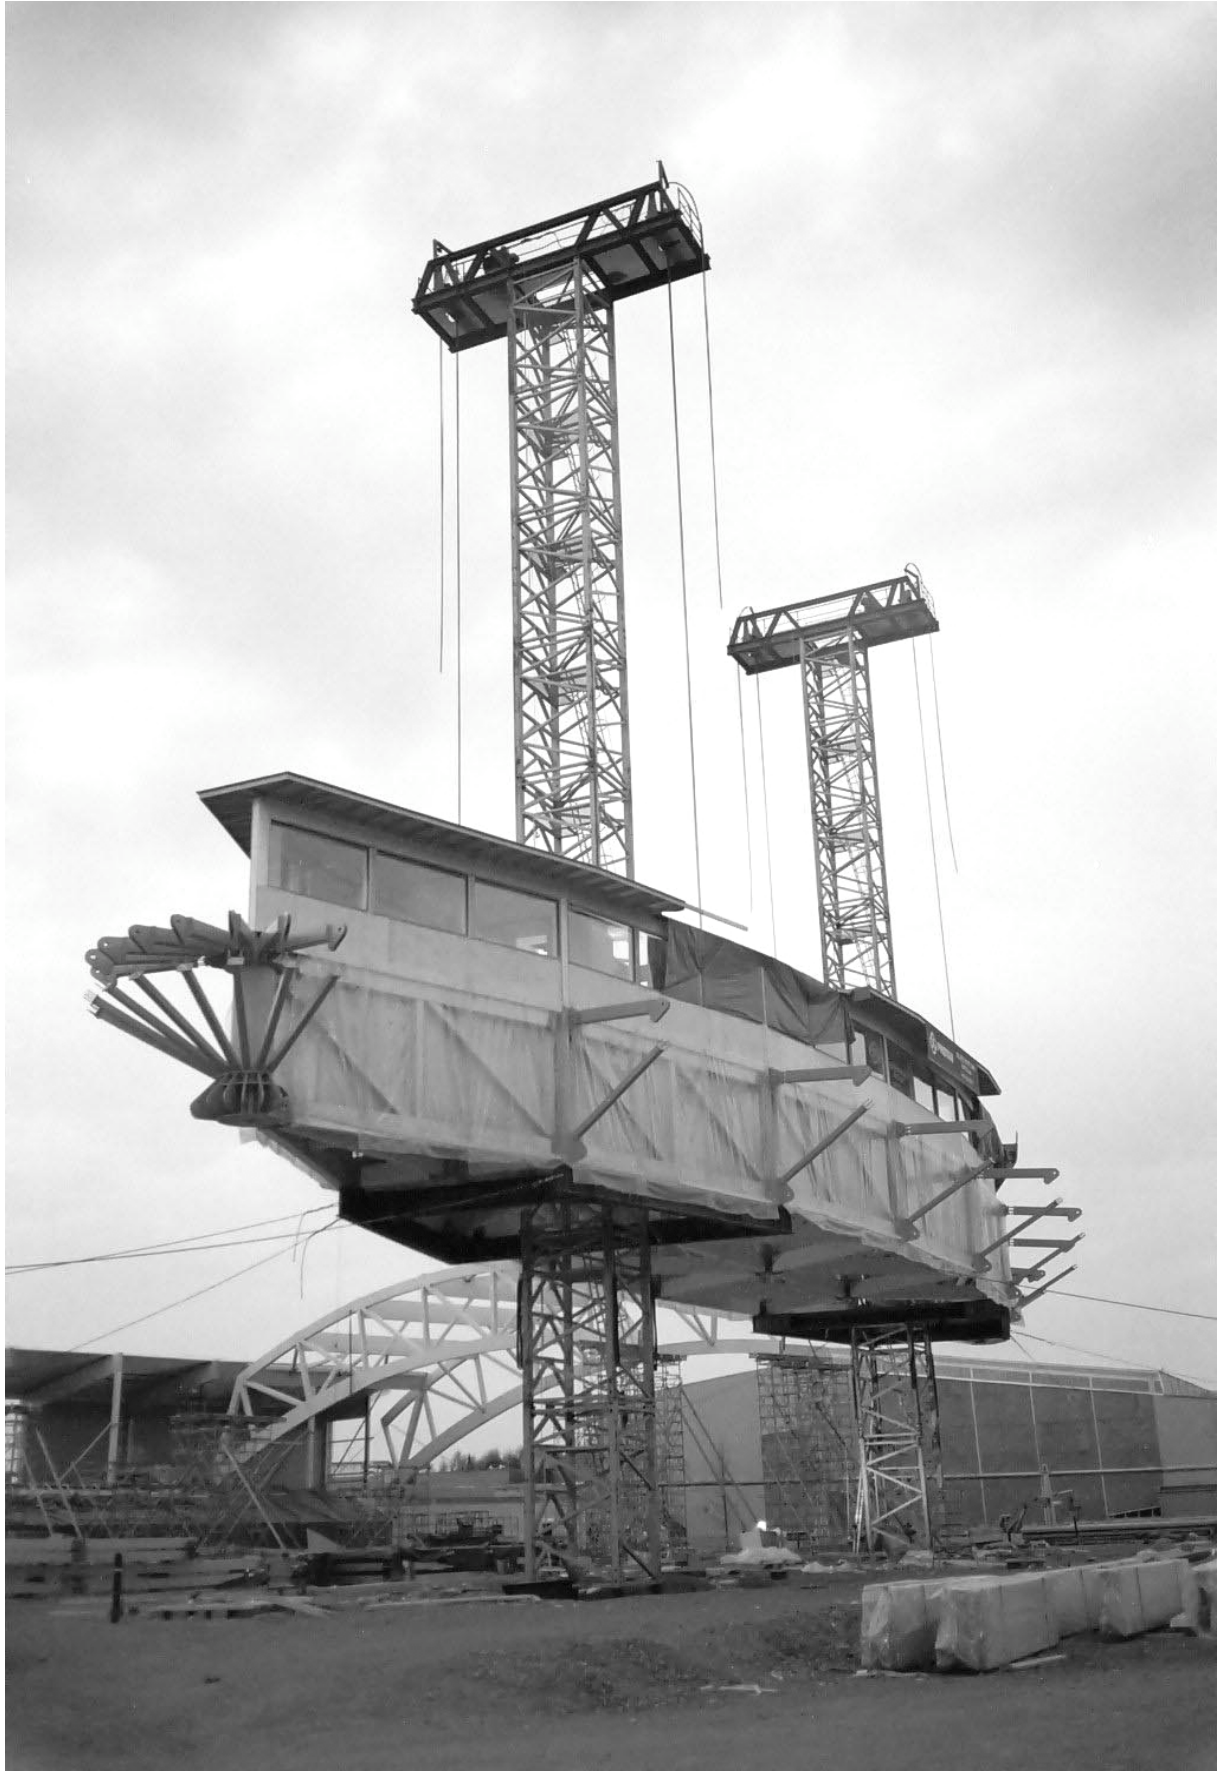
Picture 6: Hoisting of the space truss with four hydraulic jacks

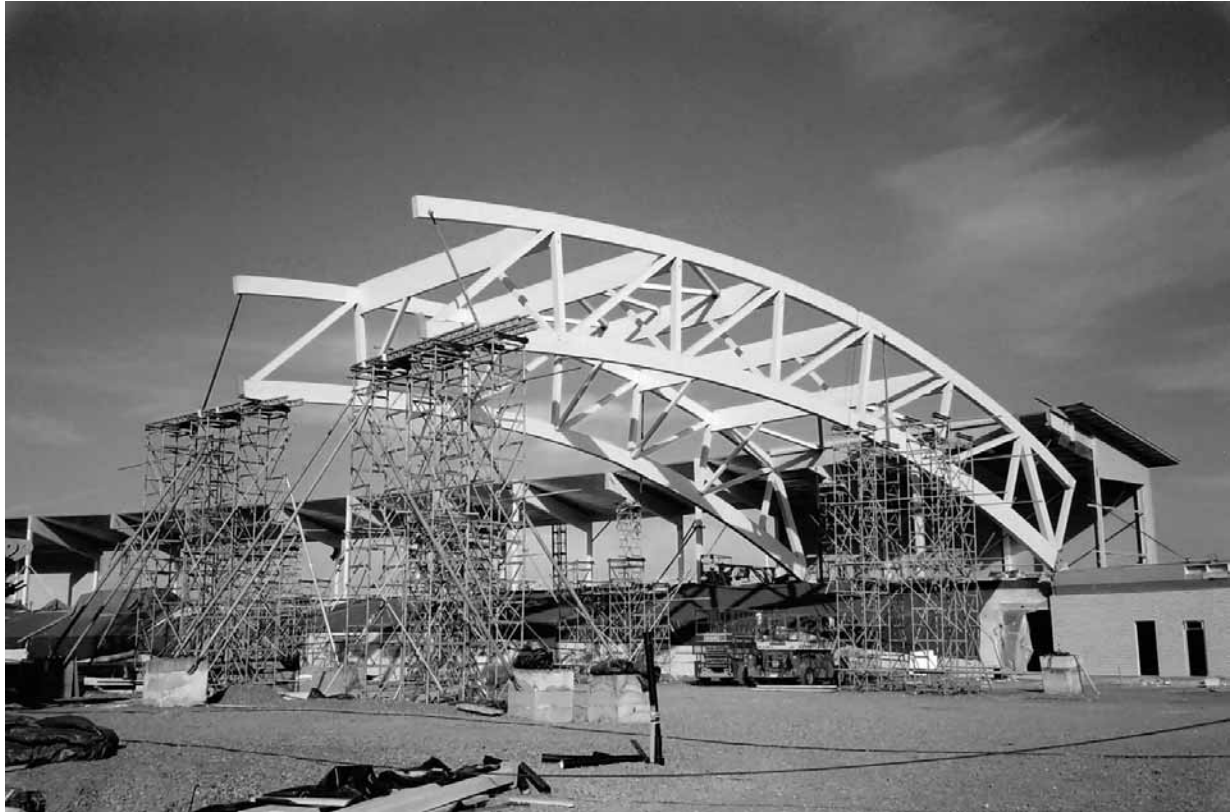
The main arcs had to be assembled on-site from three partial trusses with maximum dimensions of about 5 x 17 m². This solution was adopted due to logistical reasons, as the highway transport of larger trusses would have been unreasonably expensive and practically impossible.

The lower ends of the main arcs were supported on the foundations with joints that enabled the truss to rotate during hoisting. This solution was familiar from the design solutions of steel-structure halls. The main arcs were assembled in pairs on support towers and were connected by the purlin structures installed between them. As with the space truss, roofs and building systems were installed in the main arc sections while they were still at ground level.

Picture 7: Installation of the main arc sections

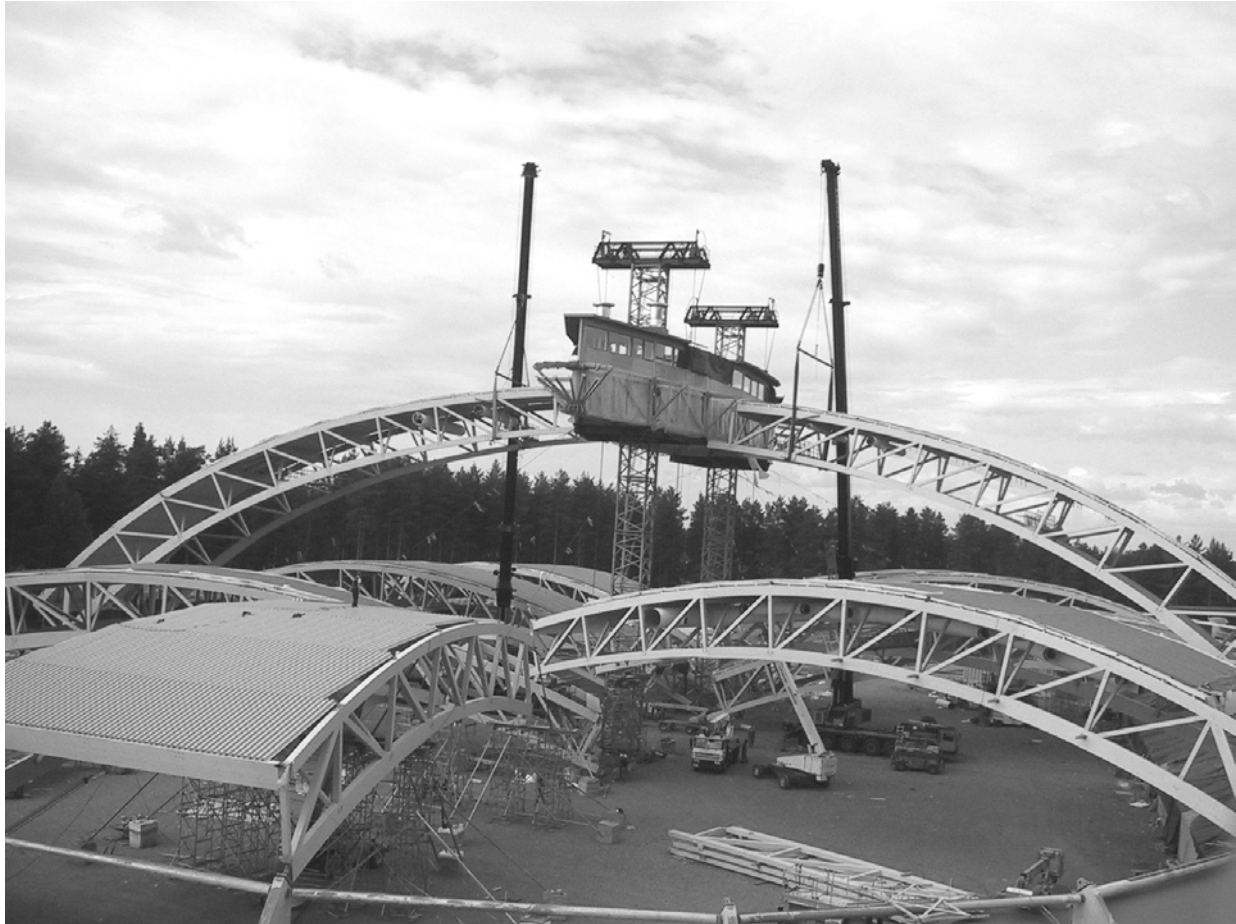
Upon completion of the preliminary installation works, the space truss was hoisted to its final height of about 31 metres. The hoisting of the main arcs was carried out using a single mobile crane of about 170 tonnes to hoist each section. This made it possible to keep the loads on the wood frame considerably more even than if, for example, paired mobile cranes had been used to hoist each of the sections. Hoisting was performed two sections at a time so that the reaction of abutment on the space truss would be symmetrical after attachment. Before the mobile cranes were detached, the main arcs were “pre-stressed” with hydraulic jacks. This established stresses in the space truss corresponding to the final stress, rather than a tensile load that would have compromised the structures.

Picture 8: Hoisting of the main arc sections with mobile cranes
